September 1988

**AERIAL PHOTOGRAPHIC PROPERTY STUDY
LOCKHEED SHIPBUILDING AND CONSTRUCTION COMPANY
SEATTLE, WASHINGTON: 1936 - 1985**

The report provides temporal views of the facility of Lockheed Shipbuilding Yard 1 using aerial photographs taken over the area from 1936 through 1985.

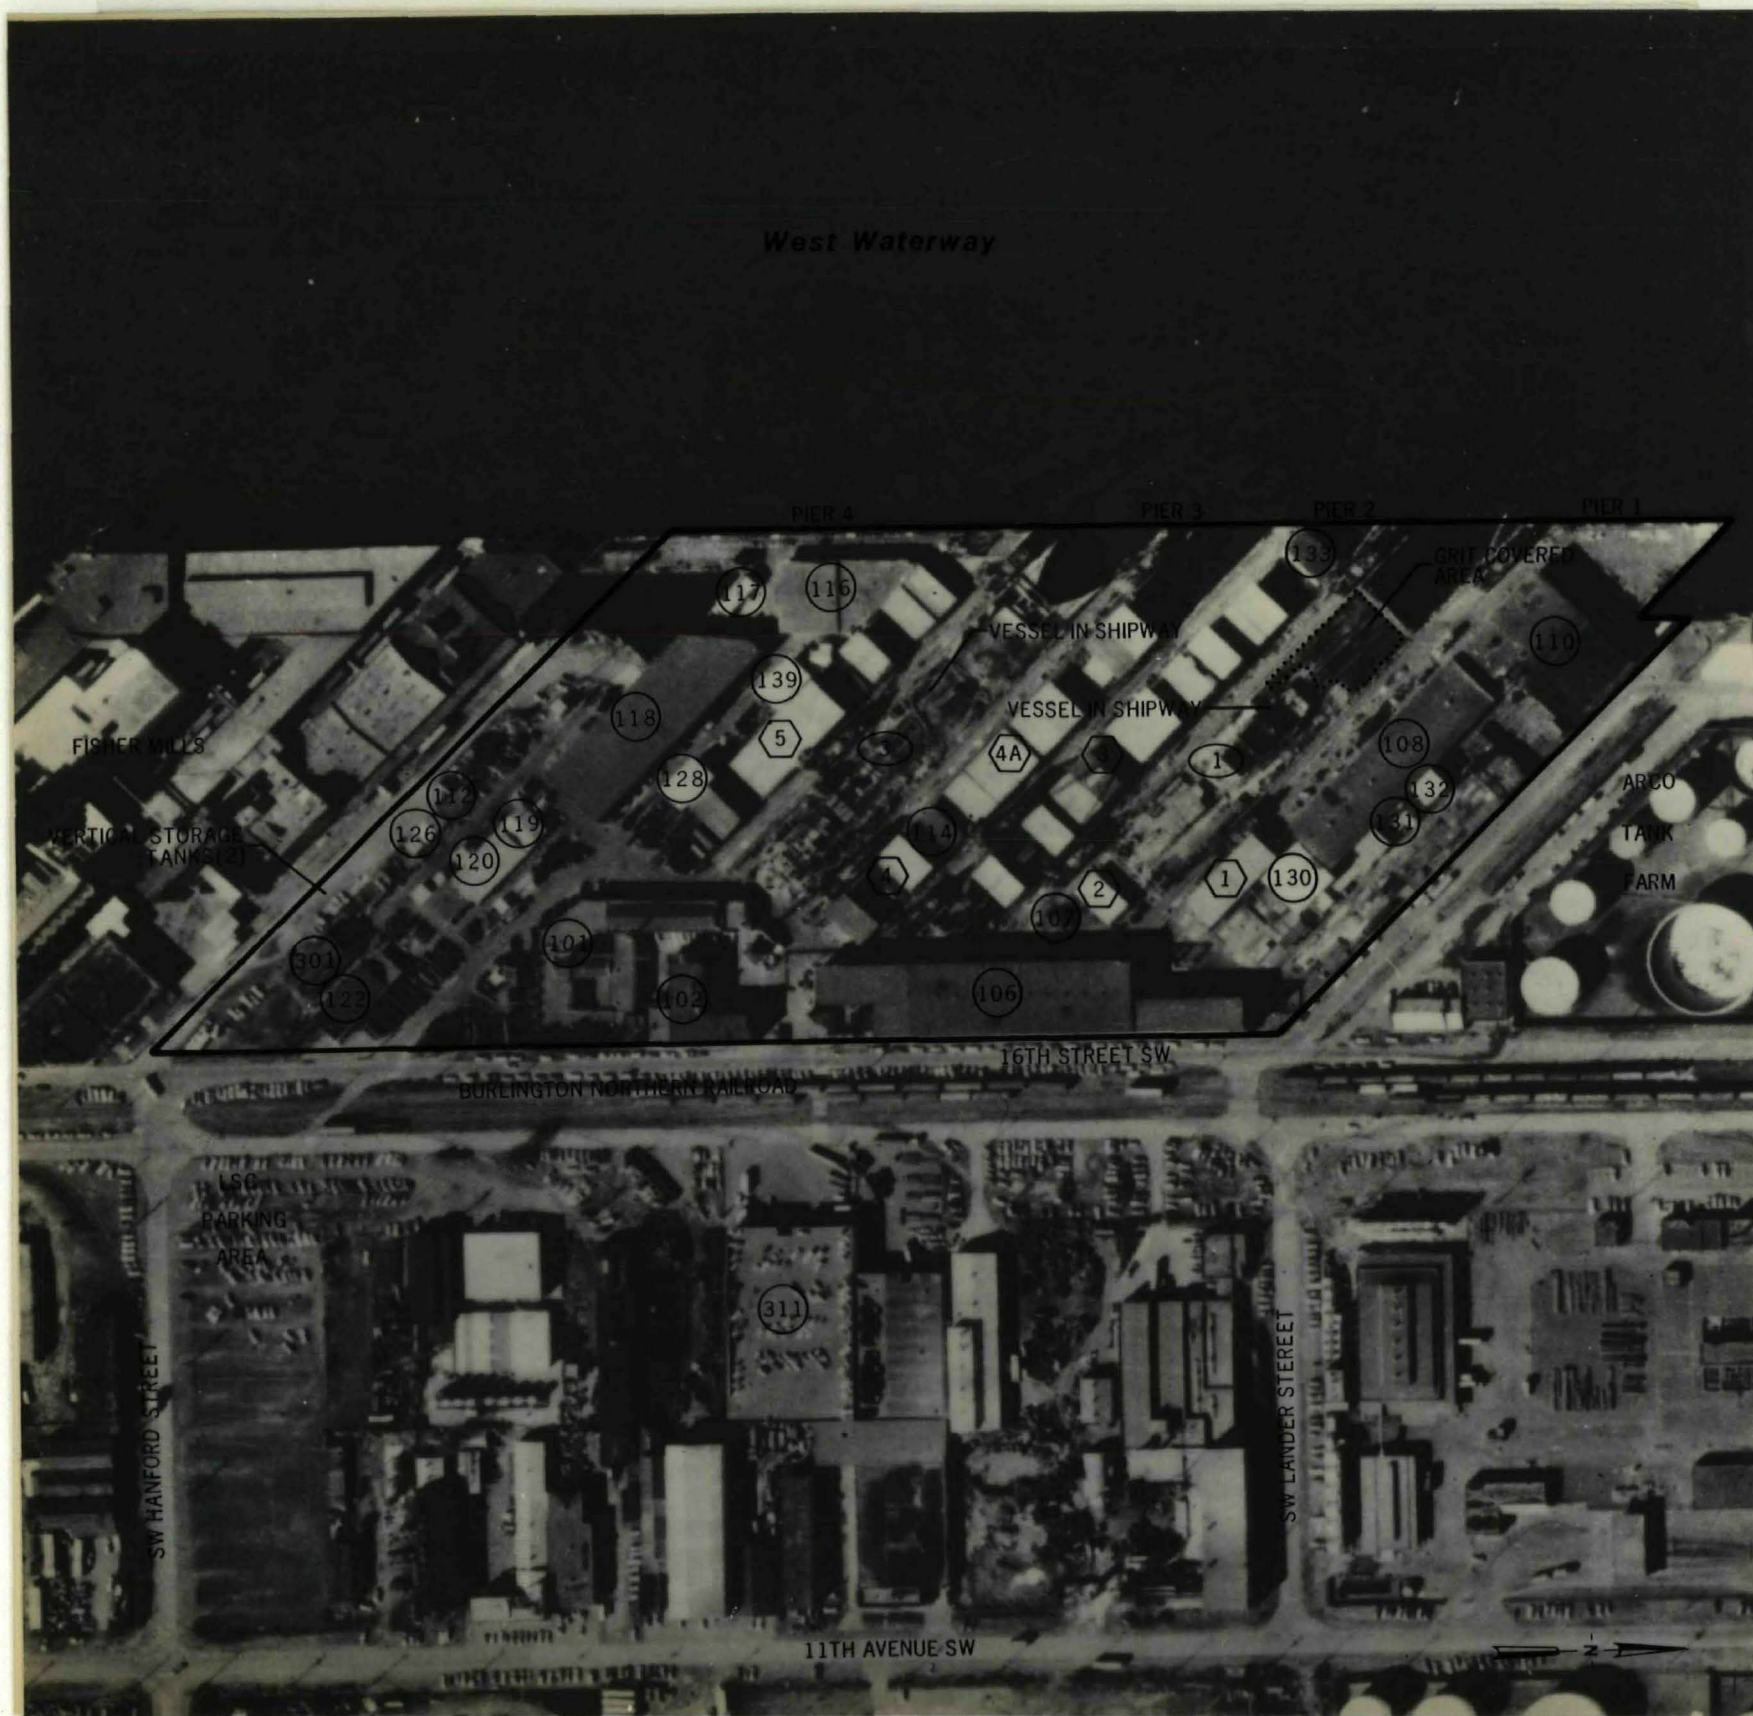
Photograph 7-7. shipyard 1: March 20, 1974. Approximate Scale, 1 inch equals 260 feet.

No substantial changes have occurred in Yard 1 facilities since 1970. Ship construction activity is high with vessels under construction in Shipways 1 and 3.

The west end of Shipway 1 is covered with a moderately heavy layer of grit.

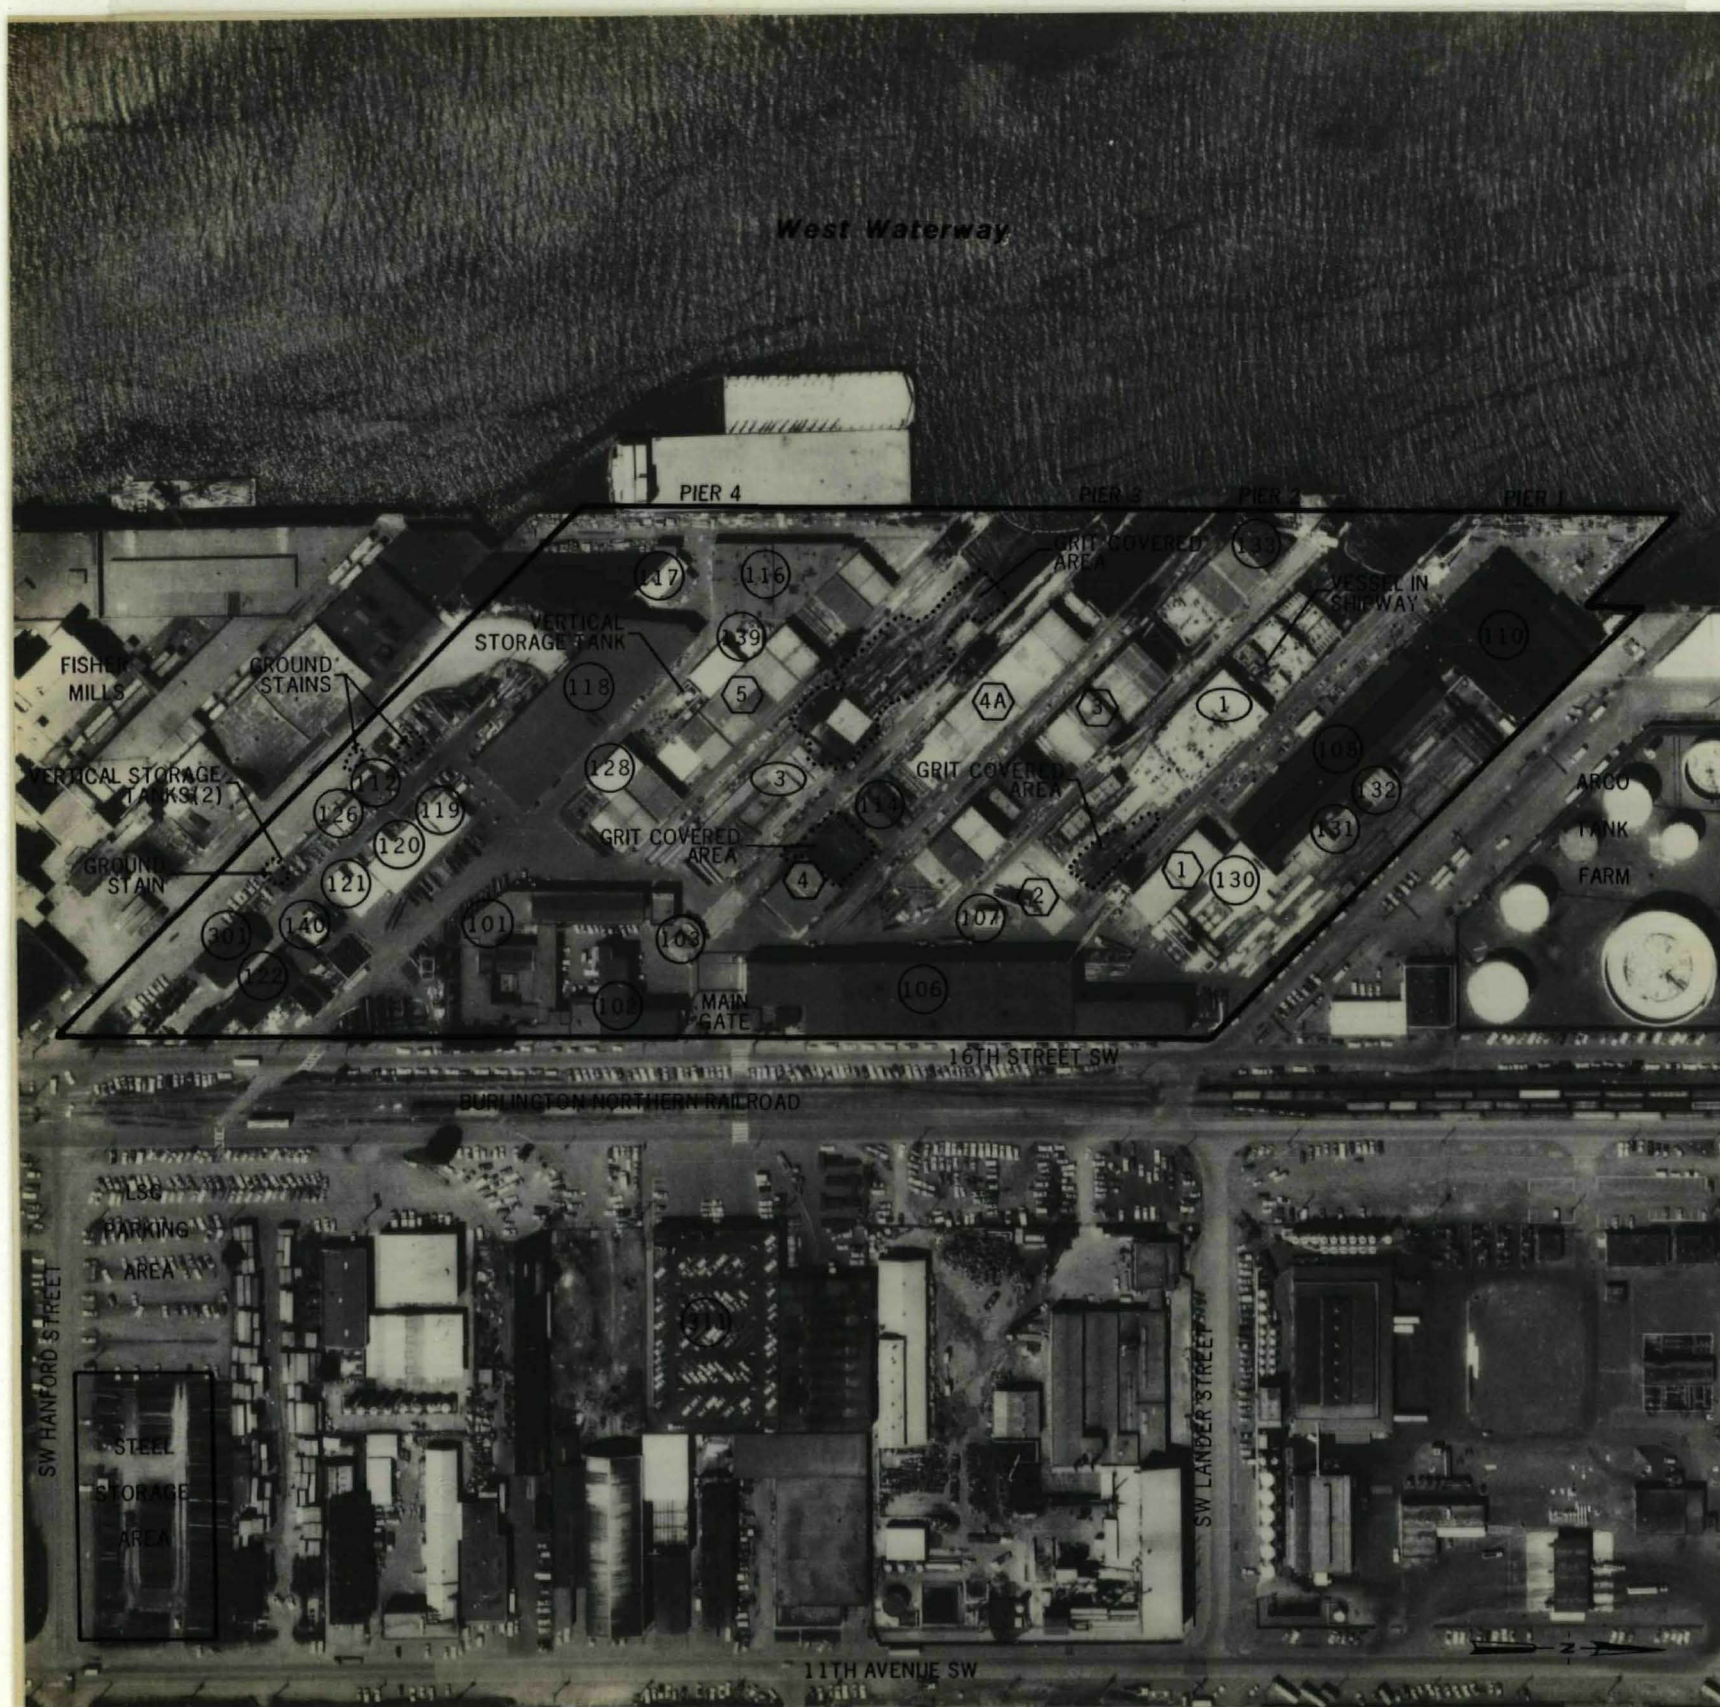
Photograph 7-8. Shipyard 1: May 31, 1978. Approximate Scale, 1 inch equals 250 feet.

✓ Ground stains are located along the southern perimeter of the property including an area directly adjacent to the storage tanks.

✓ Grit covered areas were observed on Shipways 1 and 3 and on Slab 4.

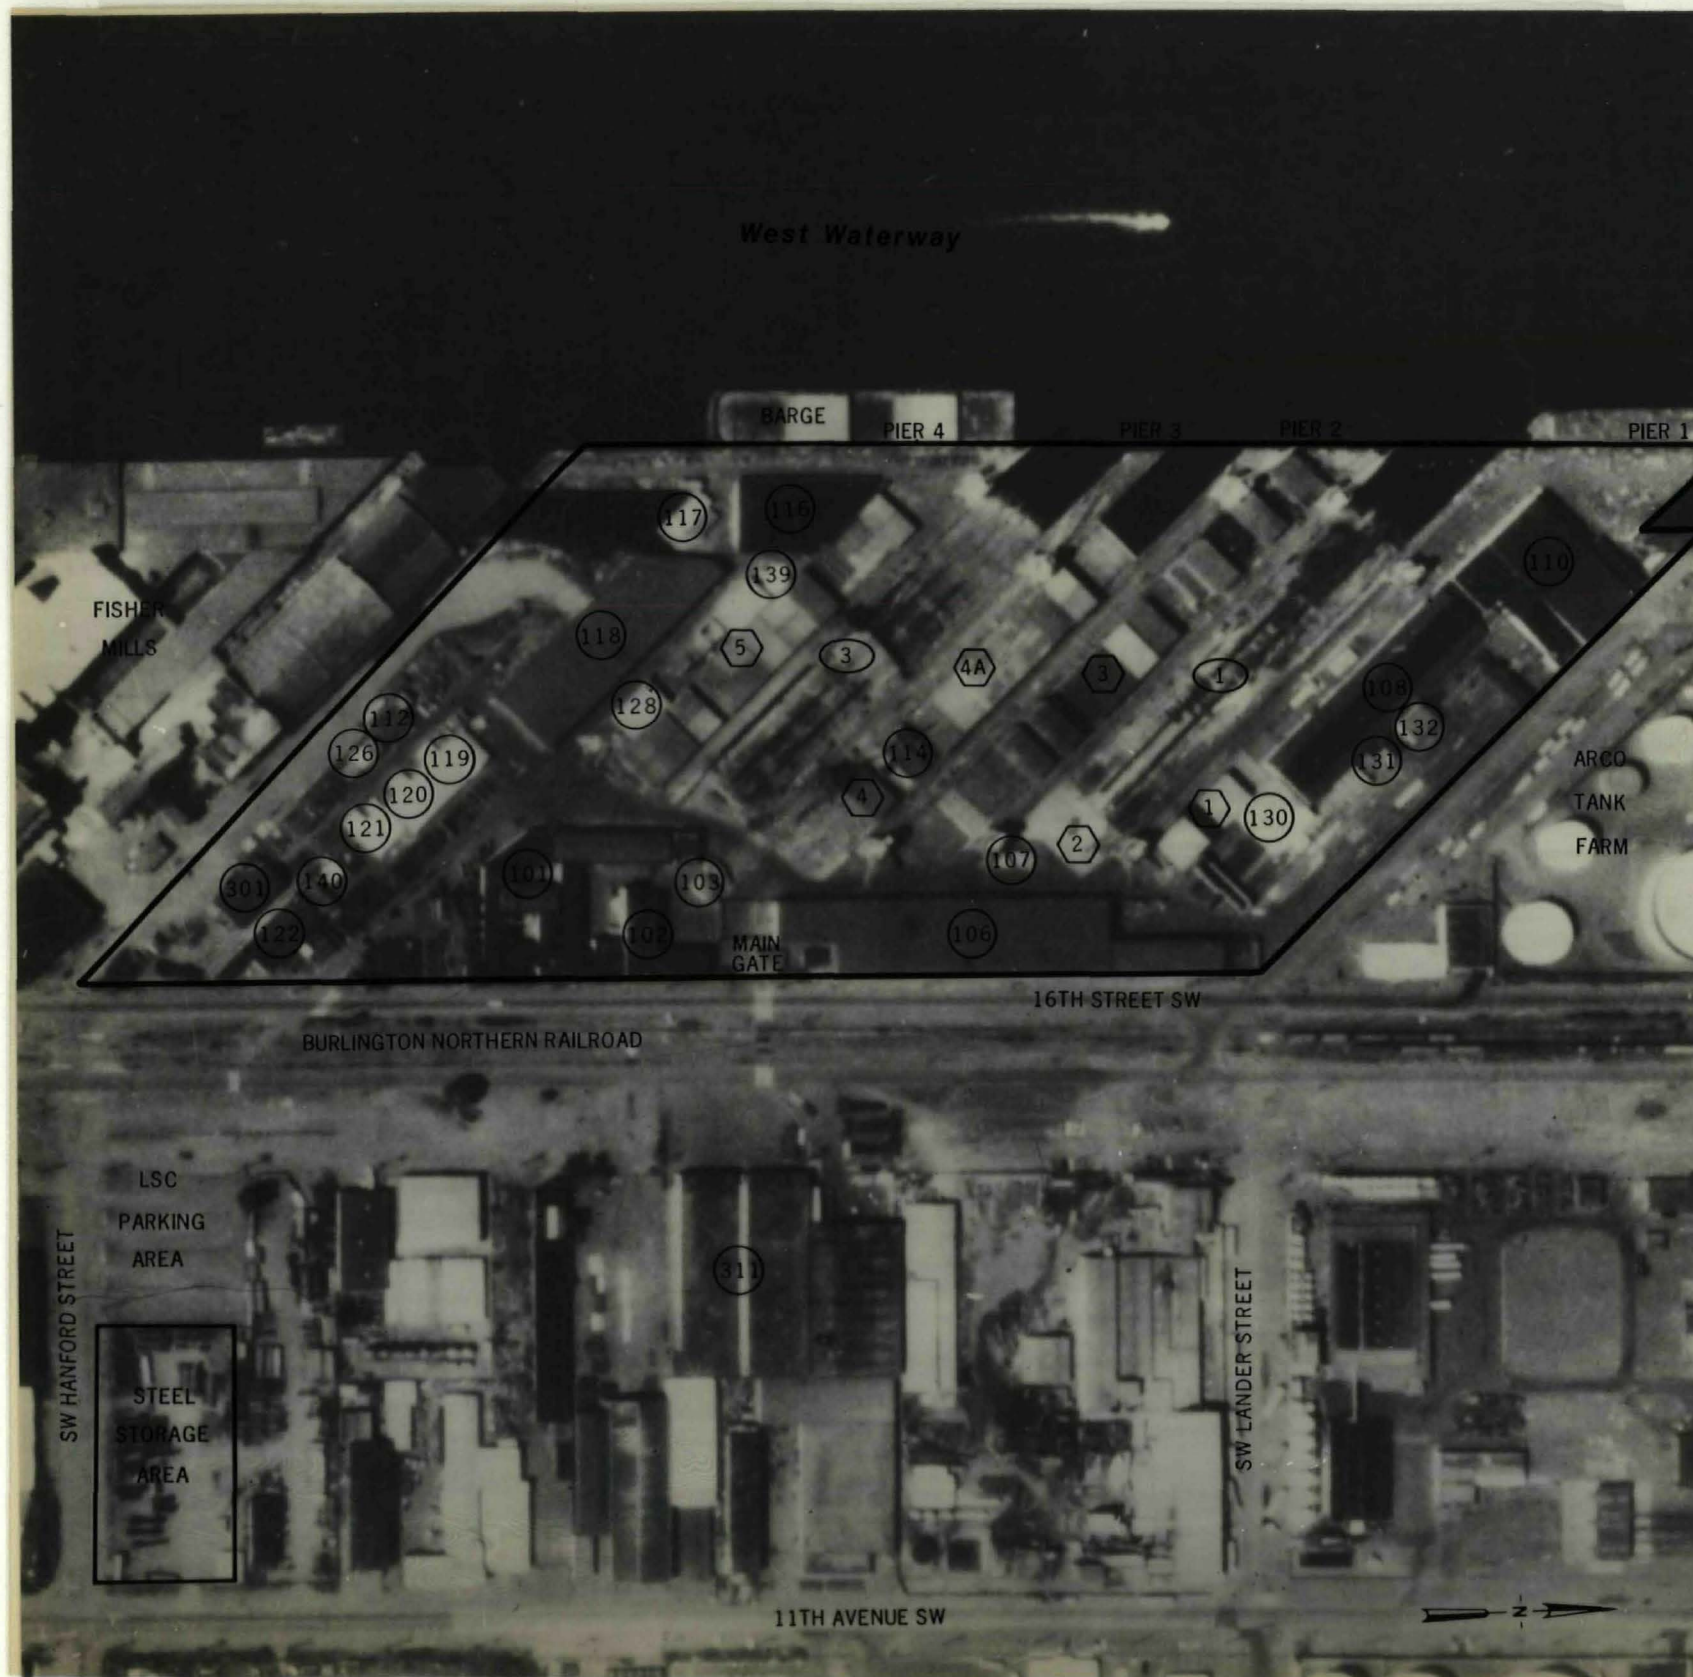
Photograph 7-9. Shipyard 1: April 27, 1980. Approximate Scale, 1 inch equals 250 feet.

In the years since the preceding photograph, no appreciable changes can be noted in the pattern of facilities development in Yard 1.

There are no visible pollution sources noted on the facility.

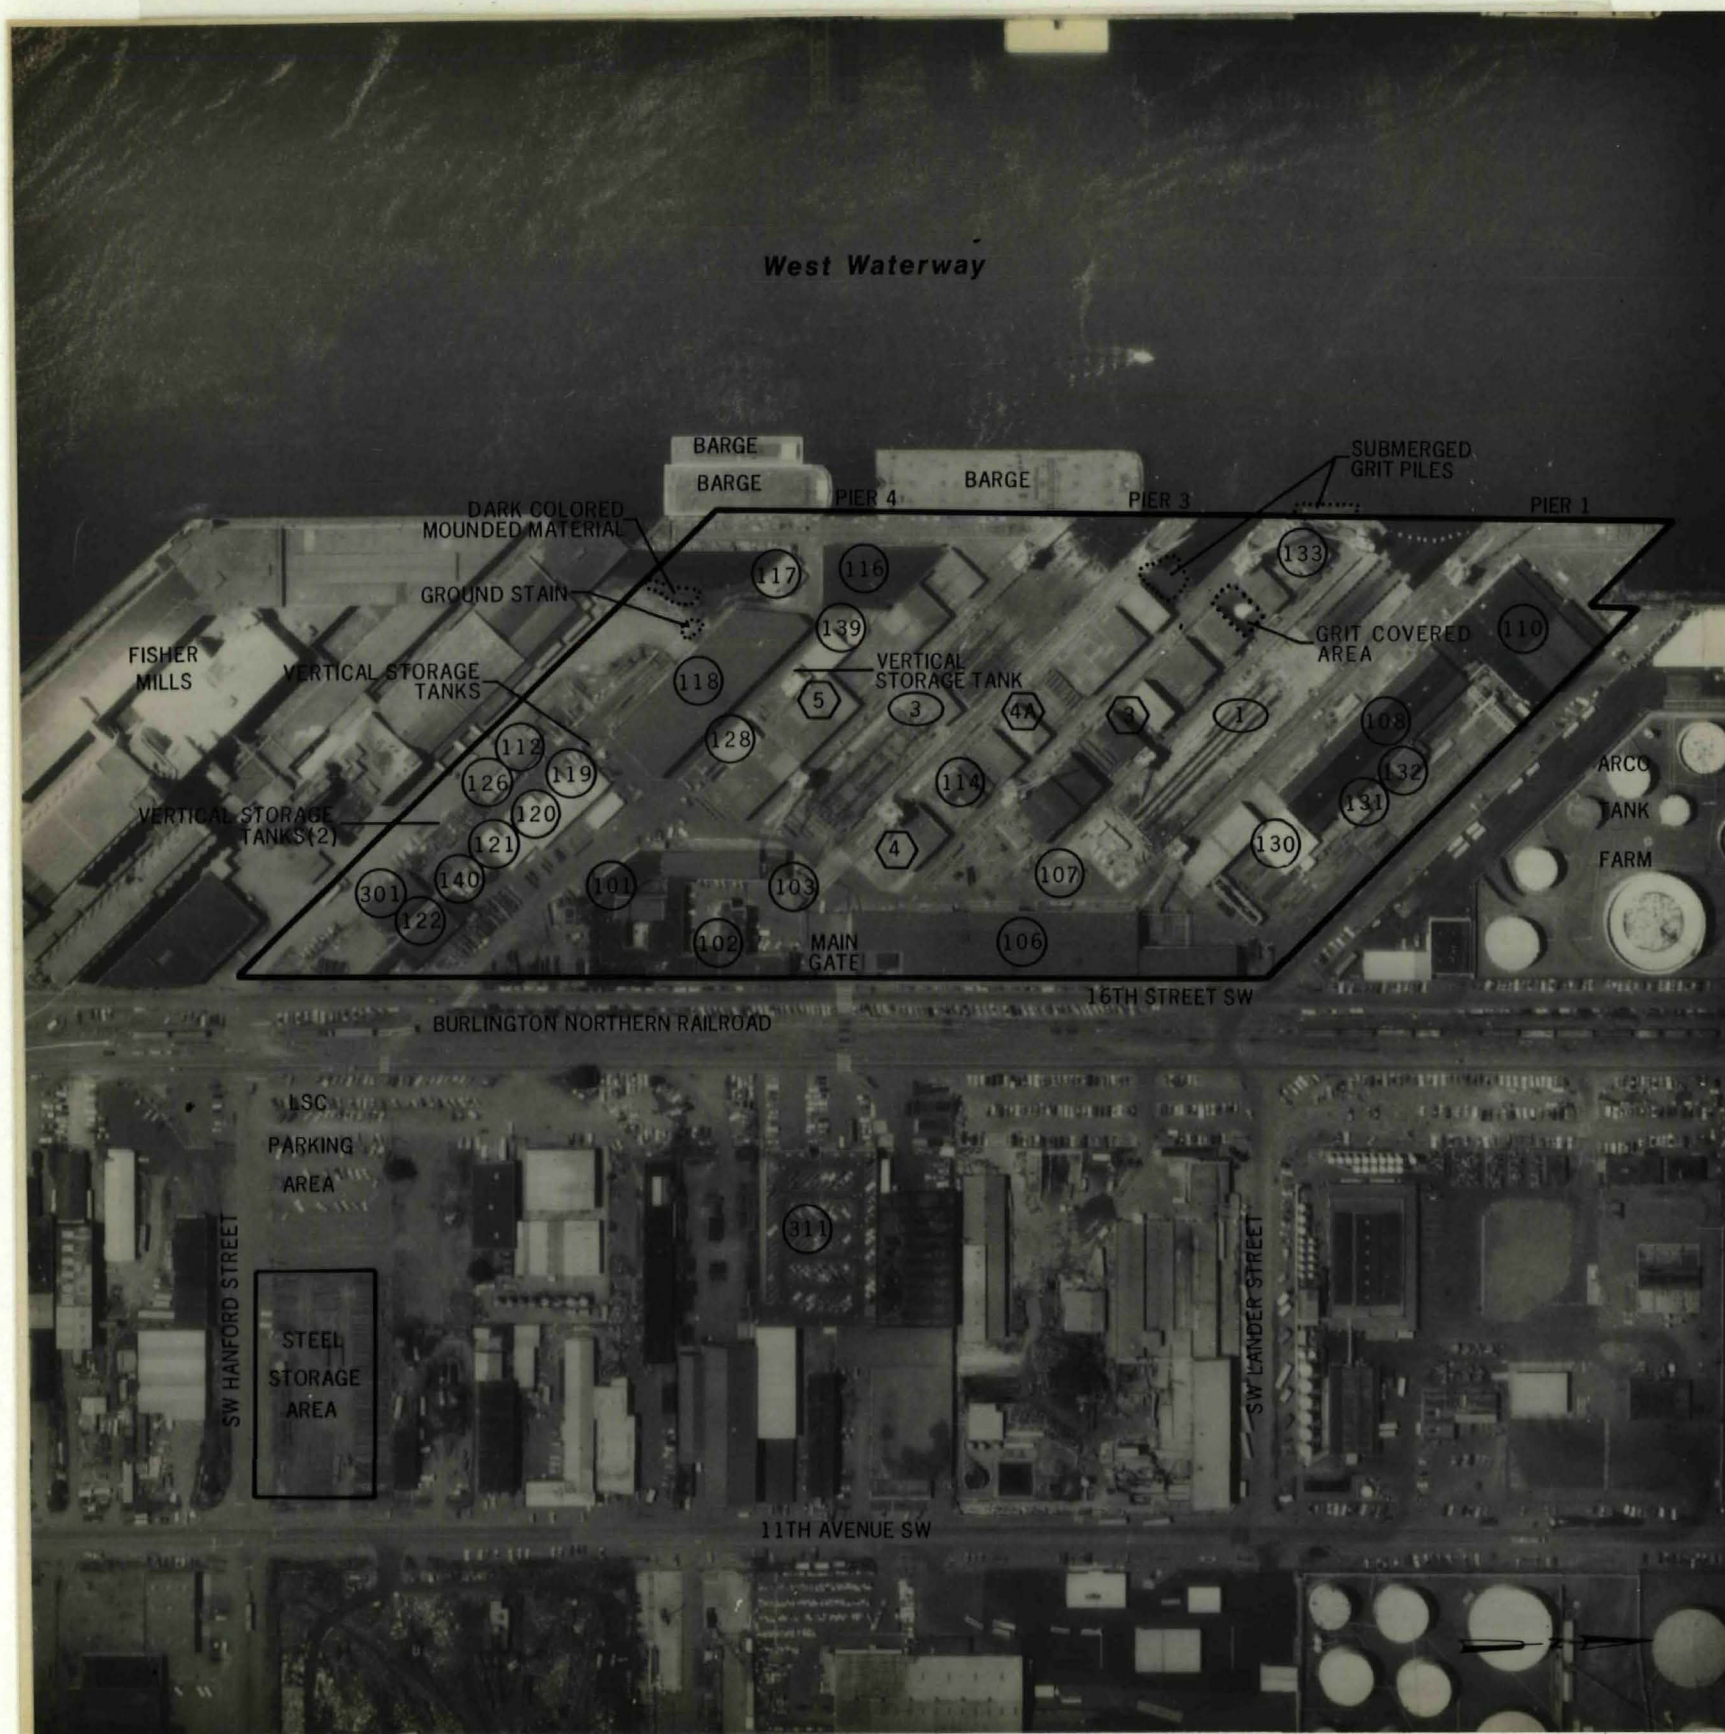
Photograph 7-10. Shipyard 1: July 16, 1981. Approximate Scale, 1 inch equals 285 feet.

✓ 4A. Submerged grit piles were observed at the west end of Slab 3 and slab. Additionally, a heavy grit layer covers a portion of the Slab 3 surface.

✓ An unidentified dark-colored, mounded material is piled adjacent to the open water area south of Building 117. This material has been identified by LSCC personnel as possible fugitive dust from steel shot blasting in Building 117.

✓ A ground stain is located on the south side of Building 118.

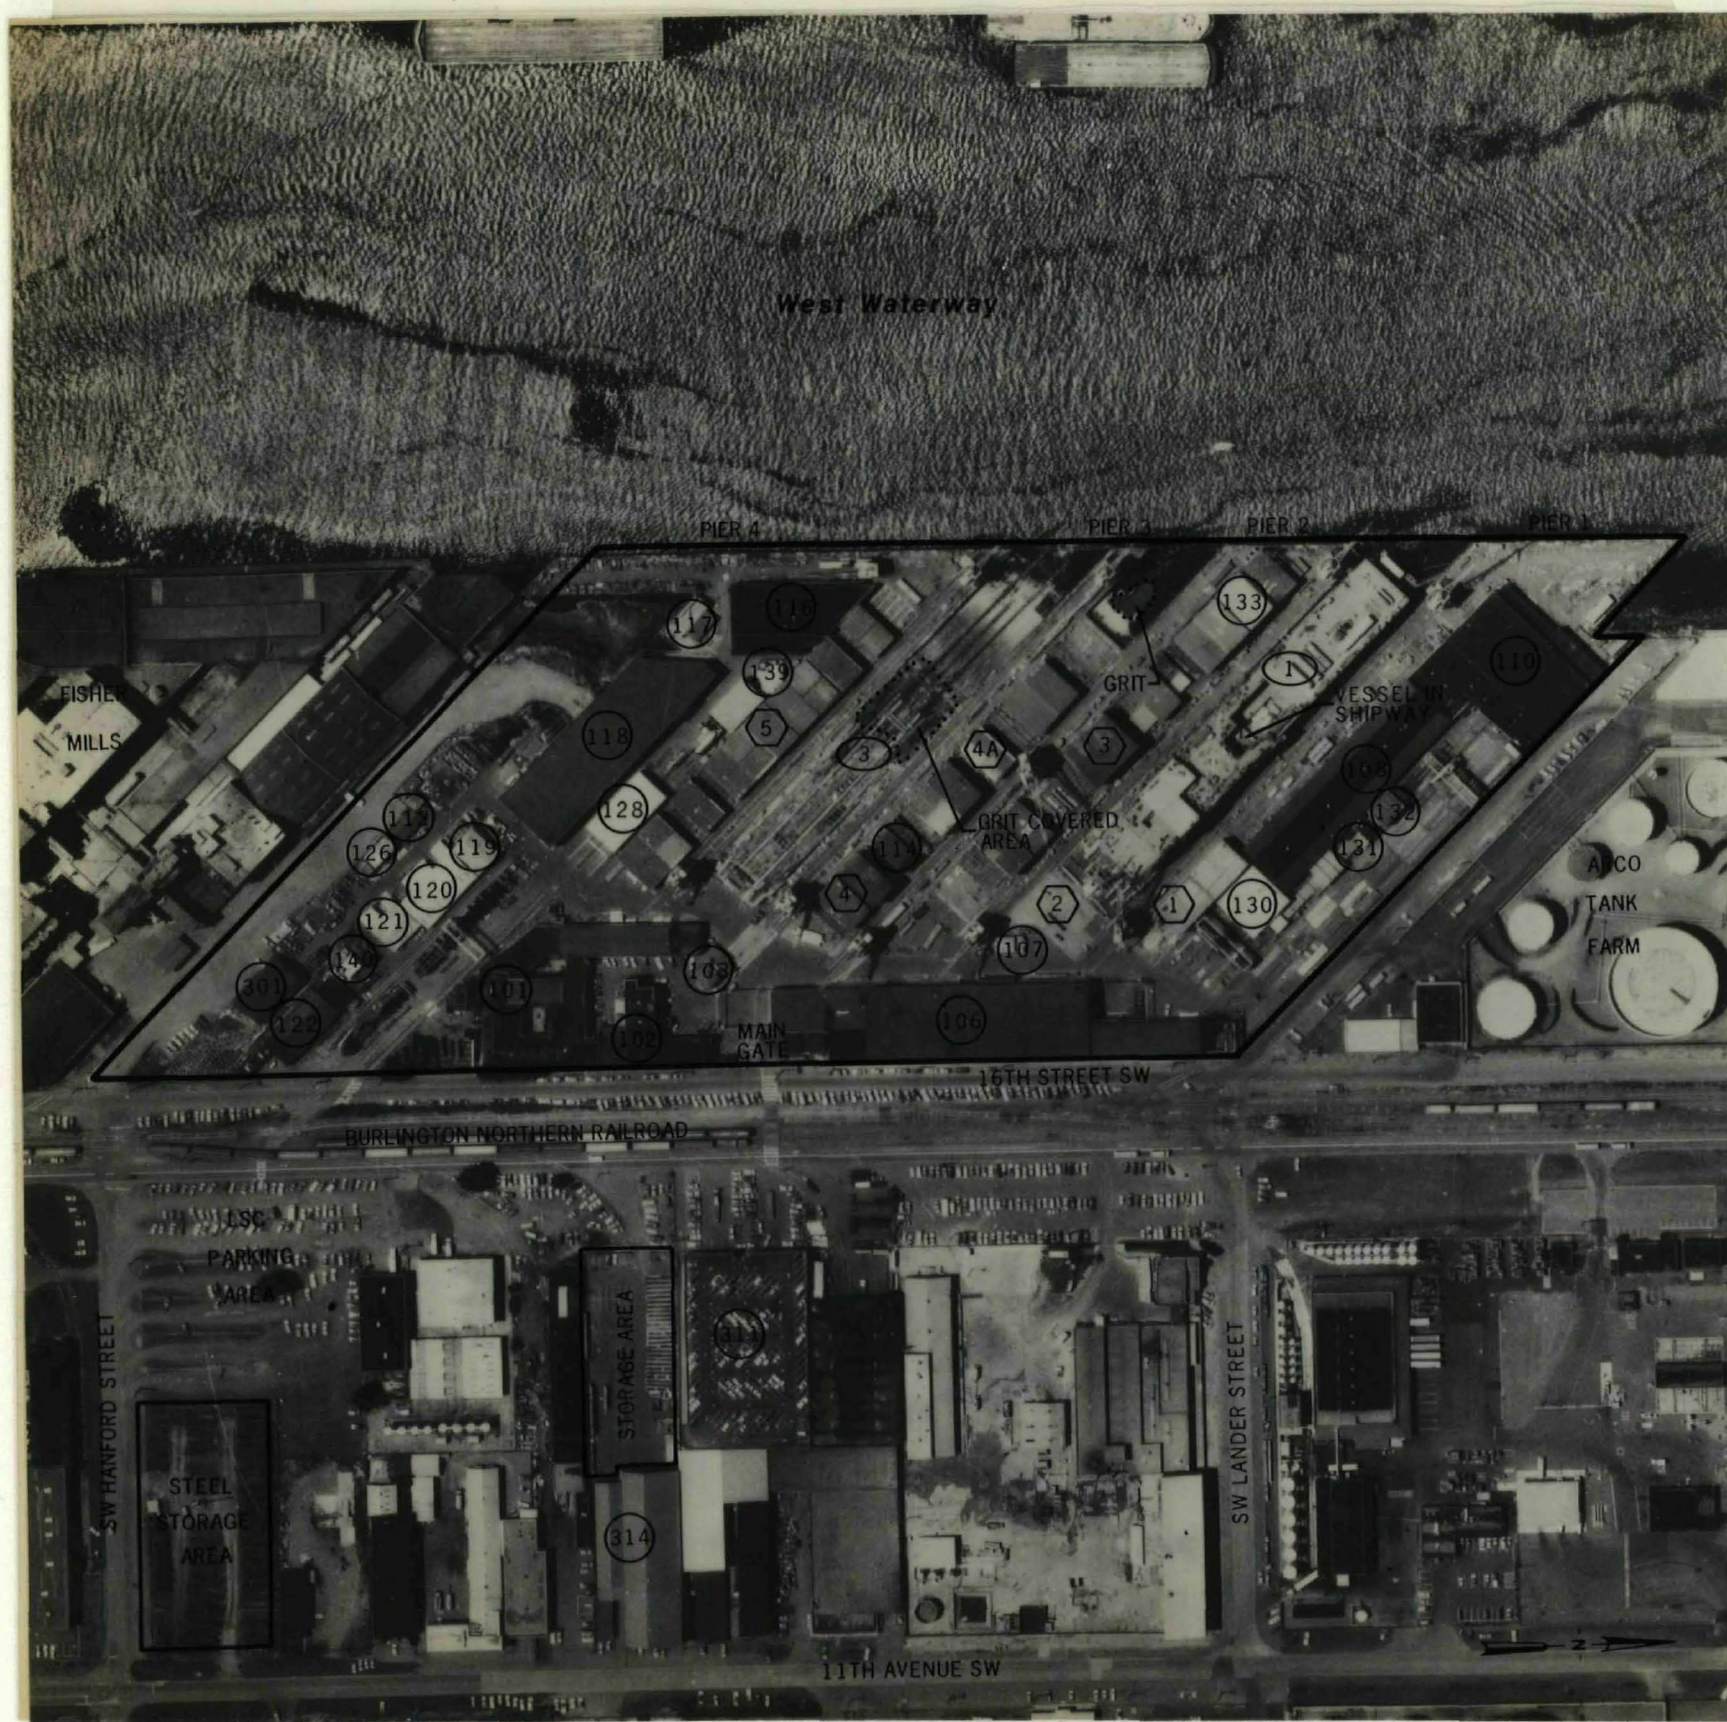
photograph 7-11. Shipyard 1: June 19, 1985. Approximate scale, 1 inch equals 260 feet.

The latest available aerial photograph of Yard 1 indicates no notable changes in facilities status since 1981. One vessel is under construction in Shipway 1. Building 314 and the other satellite storage facilities were leased in 1983 by Lockheed.

√ Grit deposits were observed in Shipway 3 and at the west end of Slab 4A. The deposit west of Slab 4A appears to be partially submerged.
